Subregional VHF Contest May/Mai 2024

Défaillance SSPA / SSPA failure

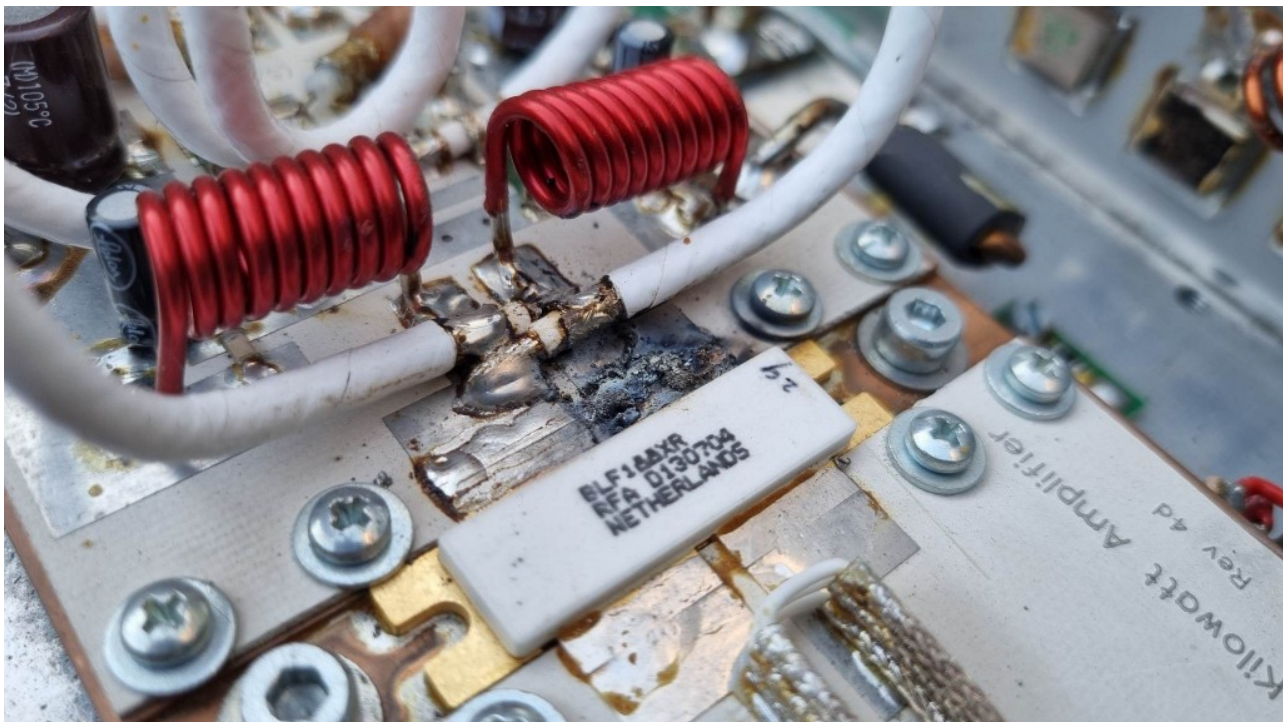
Etant donné que je suis actif sur 144 MHz en EME (terre-lune-terre), j'ai besoin de puissance RF. Après une version 300W, puis 600W, j'ai construit un SSPA (Solid State PA) de 1 kW+ en 2017 (une vidéo relative à cet ampli est disponible [ici](#)). Il est basé sur un kit de Jim, W6PQL (matériel très fiable). Le transistor utilisé est un BLF188XR. Cet ampli a parfaitement fonctionné jusque mi juin 2023. Durant une émission en mode numérique et par journée chaude (31°C), il a cessé de fonctionner ! Pour limiter les pertes, le transverter 28 <> 144 MHz et l'ampli sont disposés dans un abri au pied de mon pylône, dans le jardin. L'abri n'est pas climatisé, si bien que par les journées chaudes, le refroidisseur est déjà à 30°C+ sans avoir même émis un watt RF...

Since I'm active on 144 MHz in EME (earth-moon-earth), I need RF power. After a 300W, then a 600W version, I built a 1kW+ SSPA (Solid State PA) in 2017 (a video relating to this amp is available [here](#)). It's based on a kit from Jim, W6PQL (very reliable equipment). The transistor used is a BLF188XR. This amp worked perfectly until mid-June 2023. During a digital transmission on a hot day (31°C), it stopped

working! To limit losses, the 28 <> 144 MHz transverter and the amplifier are placed in a shelter at the foot of my tower, in the garden. The shelter is not air-conditioned, so on hot days the heatsink is already at 30°C+ without having emitted even one RF watt...
